## MEMORANDUM

**Re:** Davis Mine/Davenport Road

Gill Engineering Associates, Inc. (Gill) was retained by the Town of Rowe (the "Town") to undertake a visual condition assessment of Davis Mine / Davenport Road and provide alternatives or recommendations for improvements.

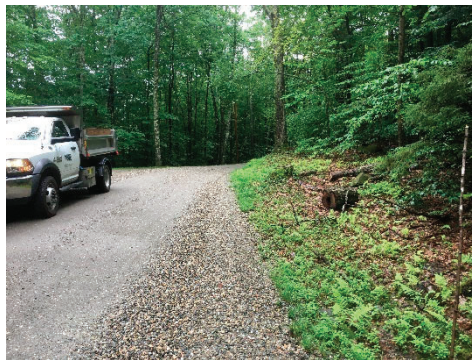
- **Mud-season rutting:** *Rutting that developed during the mud season required emergency repairs. Stone used to help make the roadway passable has loosened from roadway and can be seen collected along the edge of the road. Rutting and other roadway deficiencies are largely due to poor drainage and the freeze thaw cycle occurring during the spring/mud season.*

- Spot repairs at select locations. Locations identified during the site visit that are in need of special attention include:
  - Mud season rutting: Excavating to quality subgrade material and rebuilding the roadway using a grid and fabric will improve conditions. Fabric will keep silt and clay from being pumped from the subgrade into the gravel material. When several inches of gravel are required, a grid should be used at 6" or 12" intervals.

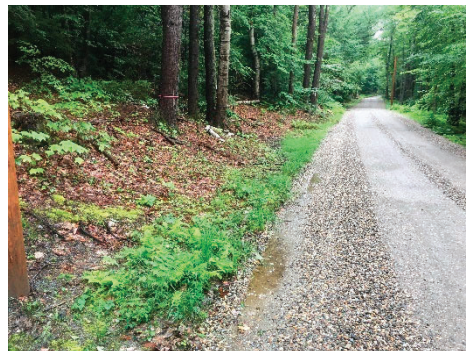
- **Standing water:** *Standing water at the edge of roadway highlights the importance of proper ditch maintenance and design. This is especially important before the winter/spring months when the freezing and thawing of trapped water can cause roadway heaving. Some areas with slate have made the recommended 2'-3' depths difficult to achieve.*

- Standing water: 2'-3' ditches are recommended. Raising the roadway profile can be a method for creating ditches. Adding material to the roadway followed by proper compaction and grading will allow for deeper more defined ditches. Ditches should have a profile that provides positive drainage along the roadway until there is a proper outlet for water away from the roadway.
