MOLD/ODOR ASSESSMENT

**Gracy House
Rowe Community Center
Zoar Road
Rowe, Massachusetts**

Prepared by:
Massachusetts Department of Public Health
Bureau of Environmental Health
Indoor Air Quality Program
November 2018

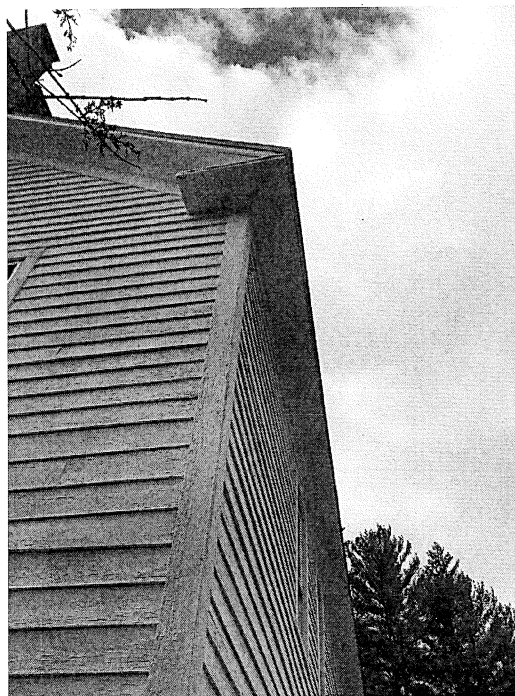
Picture 6

- A lack of gutters and downspouts (Picture 6) which can lead to water penetrating the building envelope;
- A damaged bulkhead door (Picture 7), which could allow water into the basement;
- A well in the basement (Picture 8) which can be a source of moisture if not properly closed off.

Adding to the water load along the foundation is the lack of gutters and downspouts. Downspouts should empty at least five feet from the foundation to prevent water from entering the building. Over time, these conditions can undermine the integrity of the building envelope and provide a means of water entry into the building via capillary action through concrete and masonry (Lstiburek & Brennan, 2001).

Roof edge without gutter/downspout

1. Consider installing gutters and downspouts to direct rainwater at least a distance of five feet away from the foundation.
2. Consult a building engineer as to the best method for preventing or minimizing water penetration through the foundation.
3. Consider installing a mechanical exhaust vent and necessary ductwork to vent the cellar to draw odors and eject water vapor from the building if needed.

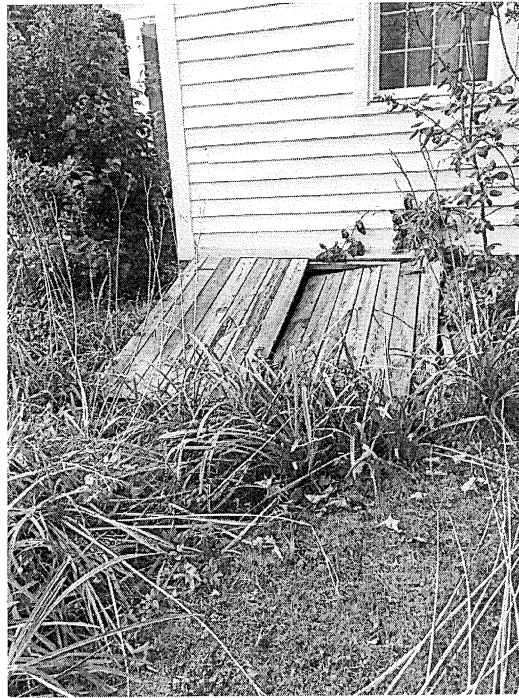
Picture 7

Damaged bulkhead doors

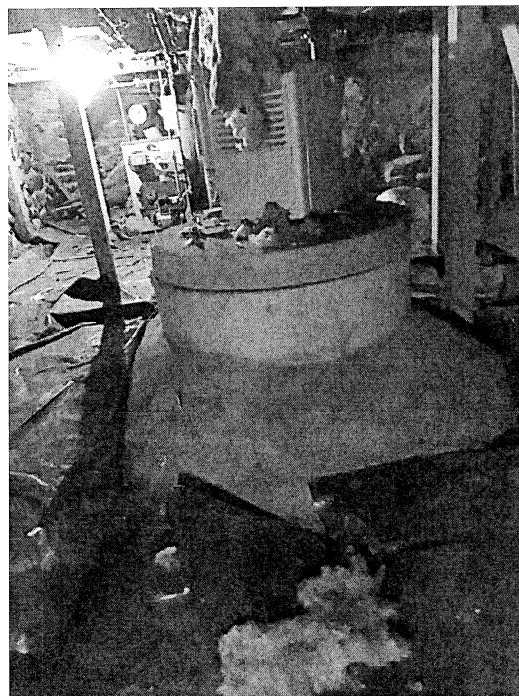
Picture 8

Sealed well head in cellar

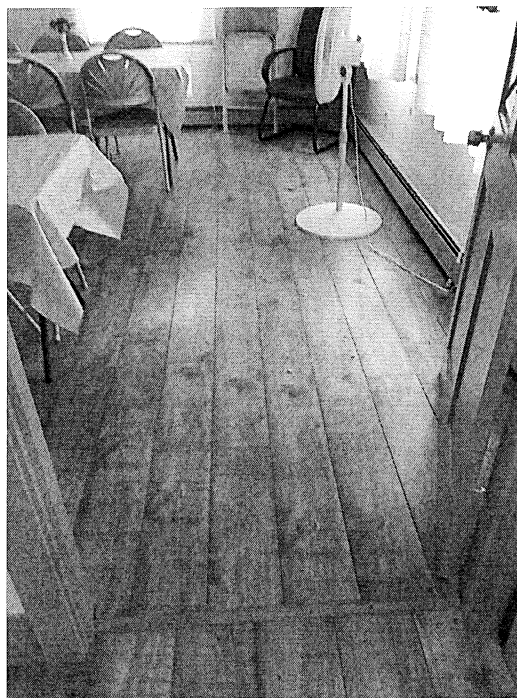
Picture 9

The first floor consists of plywood covered with tongue-in-groove laminate flooring (Picture 9), which is not designed for use in a high moisture environment. According to one manufacturer, their “flooring should not be installed over any floor with a sump pump or in a room with a floor drain” (Pergo, unknown). Laminate flooring is usually manufactured using particle board plank with a laminate applied to the surface to give the appearance of natural wood. Due to its design, water vapor cannot readily pass through the material to escape from the space below the floor. This results in the floor beams, under-flooring and laminate to be chronically exposed to moisture. This in turn, may cause the flooring to be colonized with mold.

BEH/IAQ staff conducted moisture sampling of the laminate floor, which was found to be moistened. Moisture content of materials may increase or decrease depending on building and weather conditions. In addition, a water-damaged carpet was noted on the threshold of the attic stair (Picture 11).

Laminate flooring

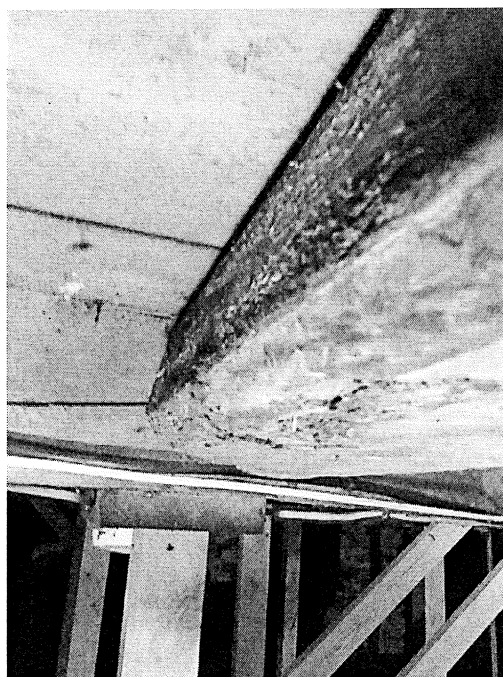
Picture 10

At the time of assessment, the basement appeared dry, however the surface of floor beams appear to be spotted with mold colonies, indicating chronic moisture exposure (Picture 10). In order for building materials to support mold growth, a source of water exposure is necessary. Building materials with increased moisture content over normal concentrations may indicate the presence or potential of mold growth.

Mold colonization on surface of floor beams

1. Remove all porous material from the cellar in a manner consistent with recommendations made in "Mold Remediation in Schools and Commercial Buildings" published by the US EPA (2008). This document can be downloaded from the US EPA website at:
http://www.epa.gov/mold/mold_remediation.html.
2. Remove carpet from cellar stair threshold.
3. Consider removing the laminate flooring and replace with a water impermeable surface e.g., floor tile.
4. Open upper-story windows during hot, humid weather to create cross ventilation to vent water vapor.
5. Repair bulkhead door.
6. Consider removing insulation blocking the bulkhead door to allow for water vapor venting.
7. Consider installing openable windows for the cellar to open during hot, humid weather to create cross ventilation.

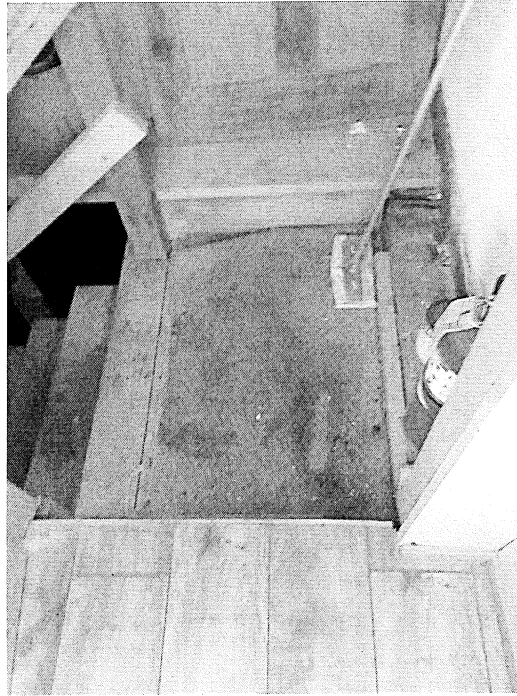
Picture 11

Water-damaged carpet on cellar stair threshold
